No. 1466299.3

CLIENT:
Hurford Wholesale Ltd.
50 Hull Road
Mt Maunganui 3149.

SAMPLE DESCRIPTION:
Flooring Planks – Aussie Native planks fixed to a perspex base using Mapei Ultrabond Eco 995. D3 PVA adhesive was applied in the joints before being assembled by the client.

ISO 4760:2022(E) - LAMINATE FLOORING – TOPICAL MOISTURE RESISTANCE – ASSEMBLED JOINT (MODIFIED)

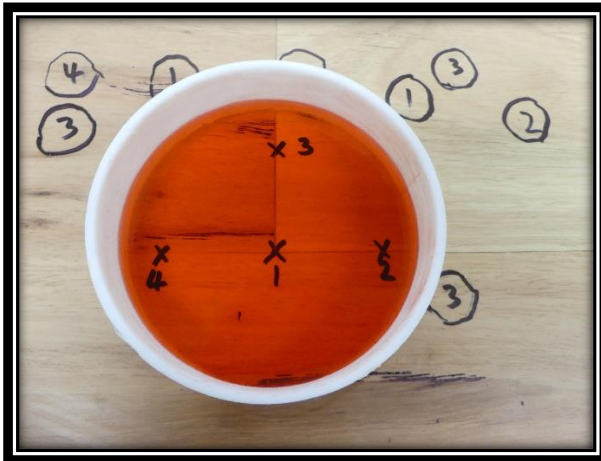
24hrs with water

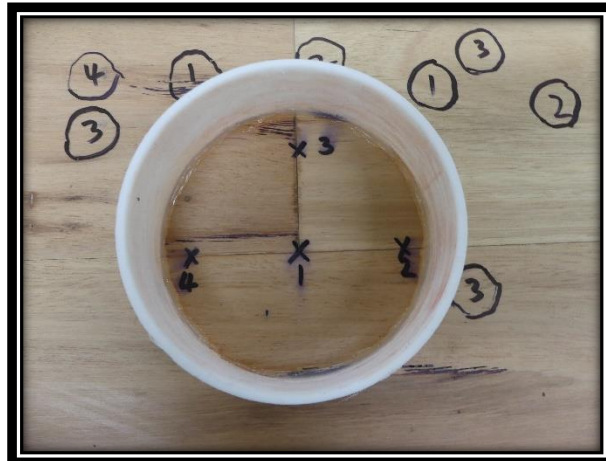
Wet Swell

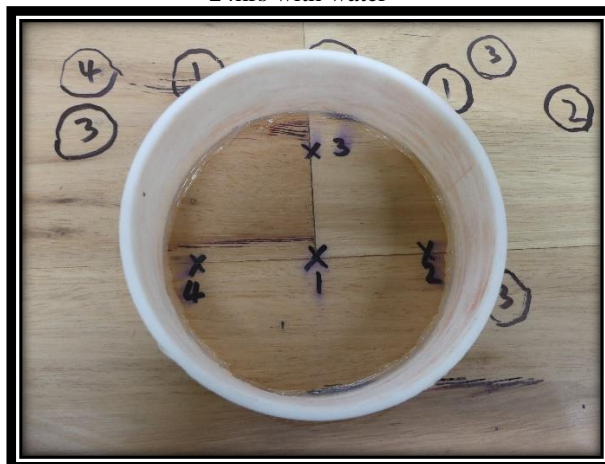
Wet Swell after recovery

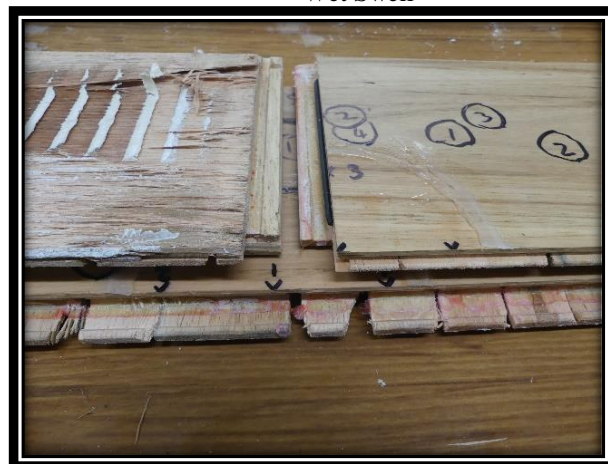
Disassembly Observations:	Specimen 1	Specimen 2	Specimen 3
Migration of water along the upper surface:	No	No	Yes
Migration of water to the underside:	No	No	Yes

Disassembled after recovery
