# No. 1466300.9

SAMPLE DESCRIPTION:  
Flooring Planks – First Floors planks fixed to a perspex base using Mapei Ultrabond Eco 995. D3 PVA adhesive was applied in the joints before being assembled by the client.

## ISO 4760:2022(E) - LAMINATE FLOORING – TOPICAL MOISTURE RESISTANCE – ASSEMBLED JOINT (MODIFIED)

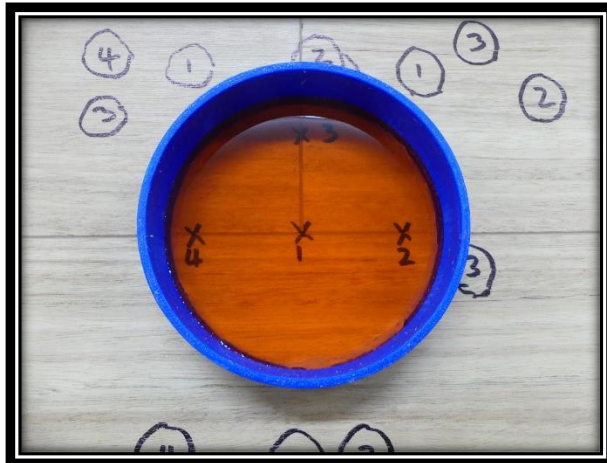
24hrs with water

100 mls of dye solution was applied onto the sample surface. It was poured into a cylinder 100mm diameter placed in the centre of the sample at the "T joint." Sealant was used at the plank/cylinder interface to avoid leakage.

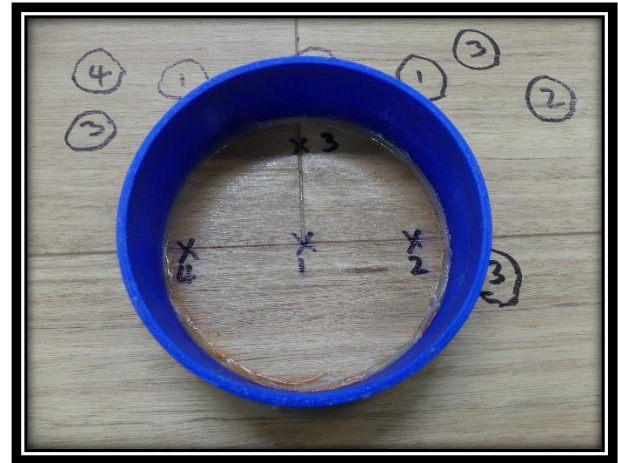
Wet Swell

Quantitative measurements are used to calculate surface swell in mm (within 15 minutes after water removal) and recovery swell (24 hours after removal of water).

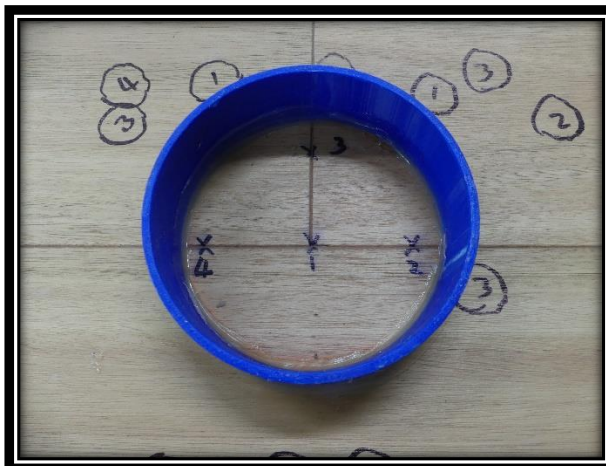
Wet Swell after recovery

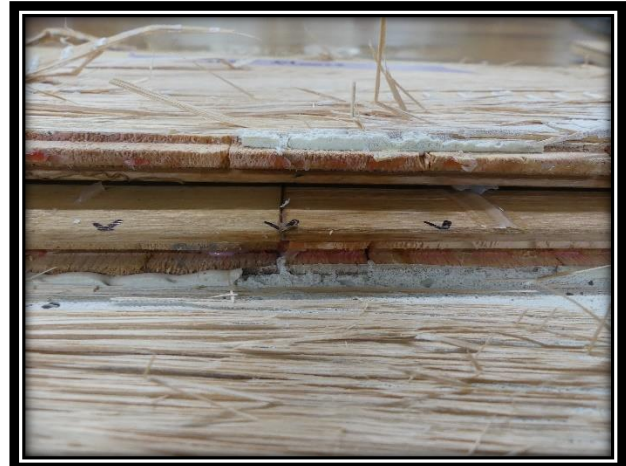
Disassembled after recovery
