# No. 1466298.5

SAMPLE DESCRIPTION:  
Flooring Planks – Genuine Oak planks fixed to a perspex base using Mapei Ultrabond Eco 995. D3 PVA adhesive was applied in the joints before being assembled by the client.

## ISO 4760:2022(E) - LAMINATE FLOORING – TOPICAL MOISTURE RESISTANCE – ASSEMBLED JOINT (MODIFIED)

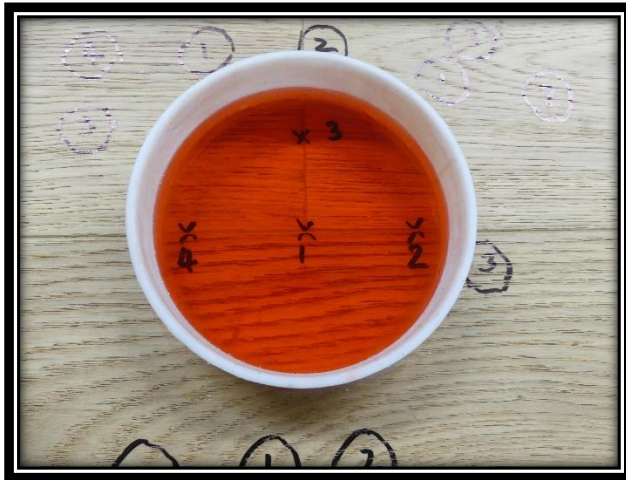
24hrs with water

100 mls of dye solution was applied onto the sample surface. It was poured into a cylinder 100mm diameter placed in the centre of the sample at the "T joint." Sealant was used at the plank/cylinder interface to avoid leakage.

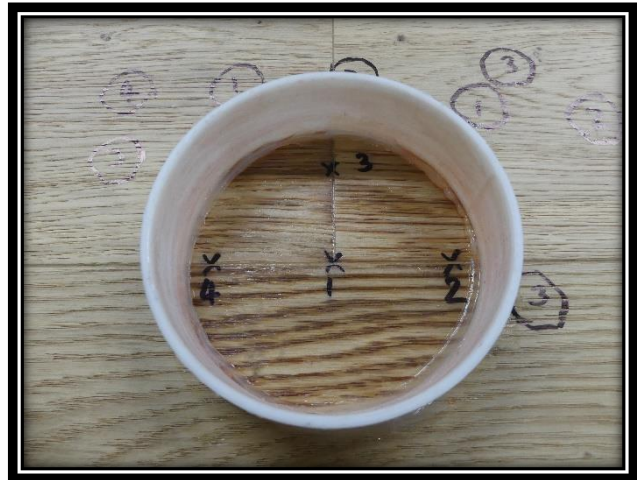
Wet Swell

Quantitative measurements are used to calculate surface swell in mm (within 15 minutes after water removal) and recovery swell (24 hours after removal of water).

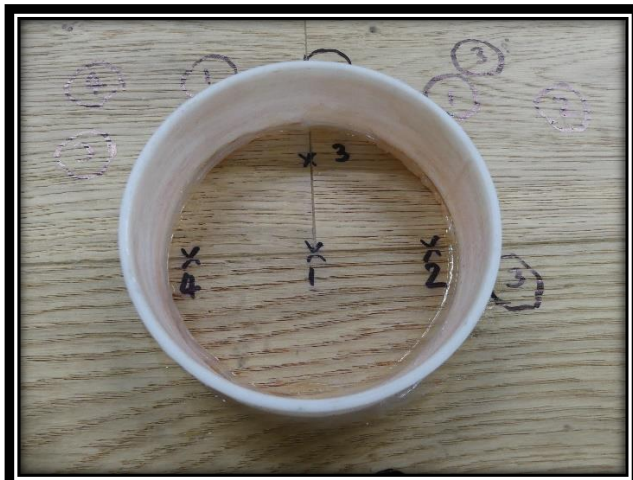
Wet Swell after recovery

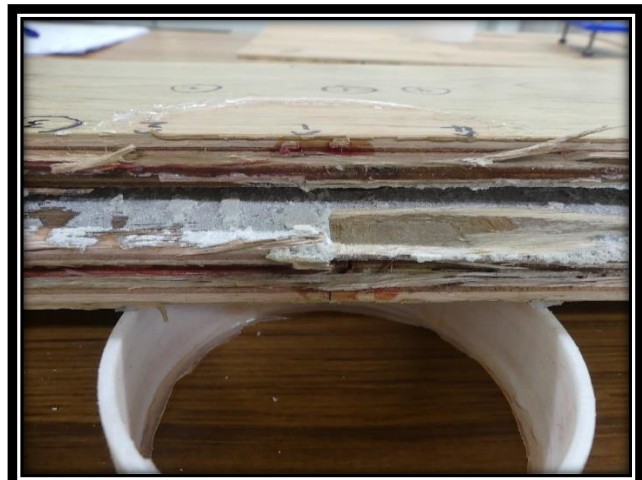
Disassembled after recovery
