No. 1466297.7

SAMPLE DESCRIPTION:
Flooring Planks – Naked Oak planks fixed to a perspex base using Mapei Ultrabond Eco 995. D3 PVA adhesive was applied in the joints before being assembled by the client.

ISO 4760:2022(E) - LAMINATE FLOORING – TOPICAL MOISTURE RESISTANCE – ASSEMBLED JOINT (MODIFIED)

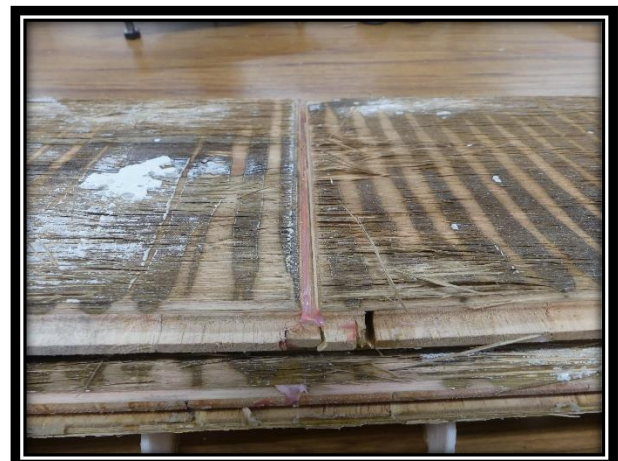
Disassembled after recovery
